# **VAPOR INTRUSION MITIGATION PLAN**

**FORMER TETERS FLORAL PROPERTY  
912 SOUTH CHURCH AVENUE  
LOUISVILLE, MISSISSIPPI**

**PPM PROJECT NO. 30065902-04-CAP01**

**JULY 7, 2023**

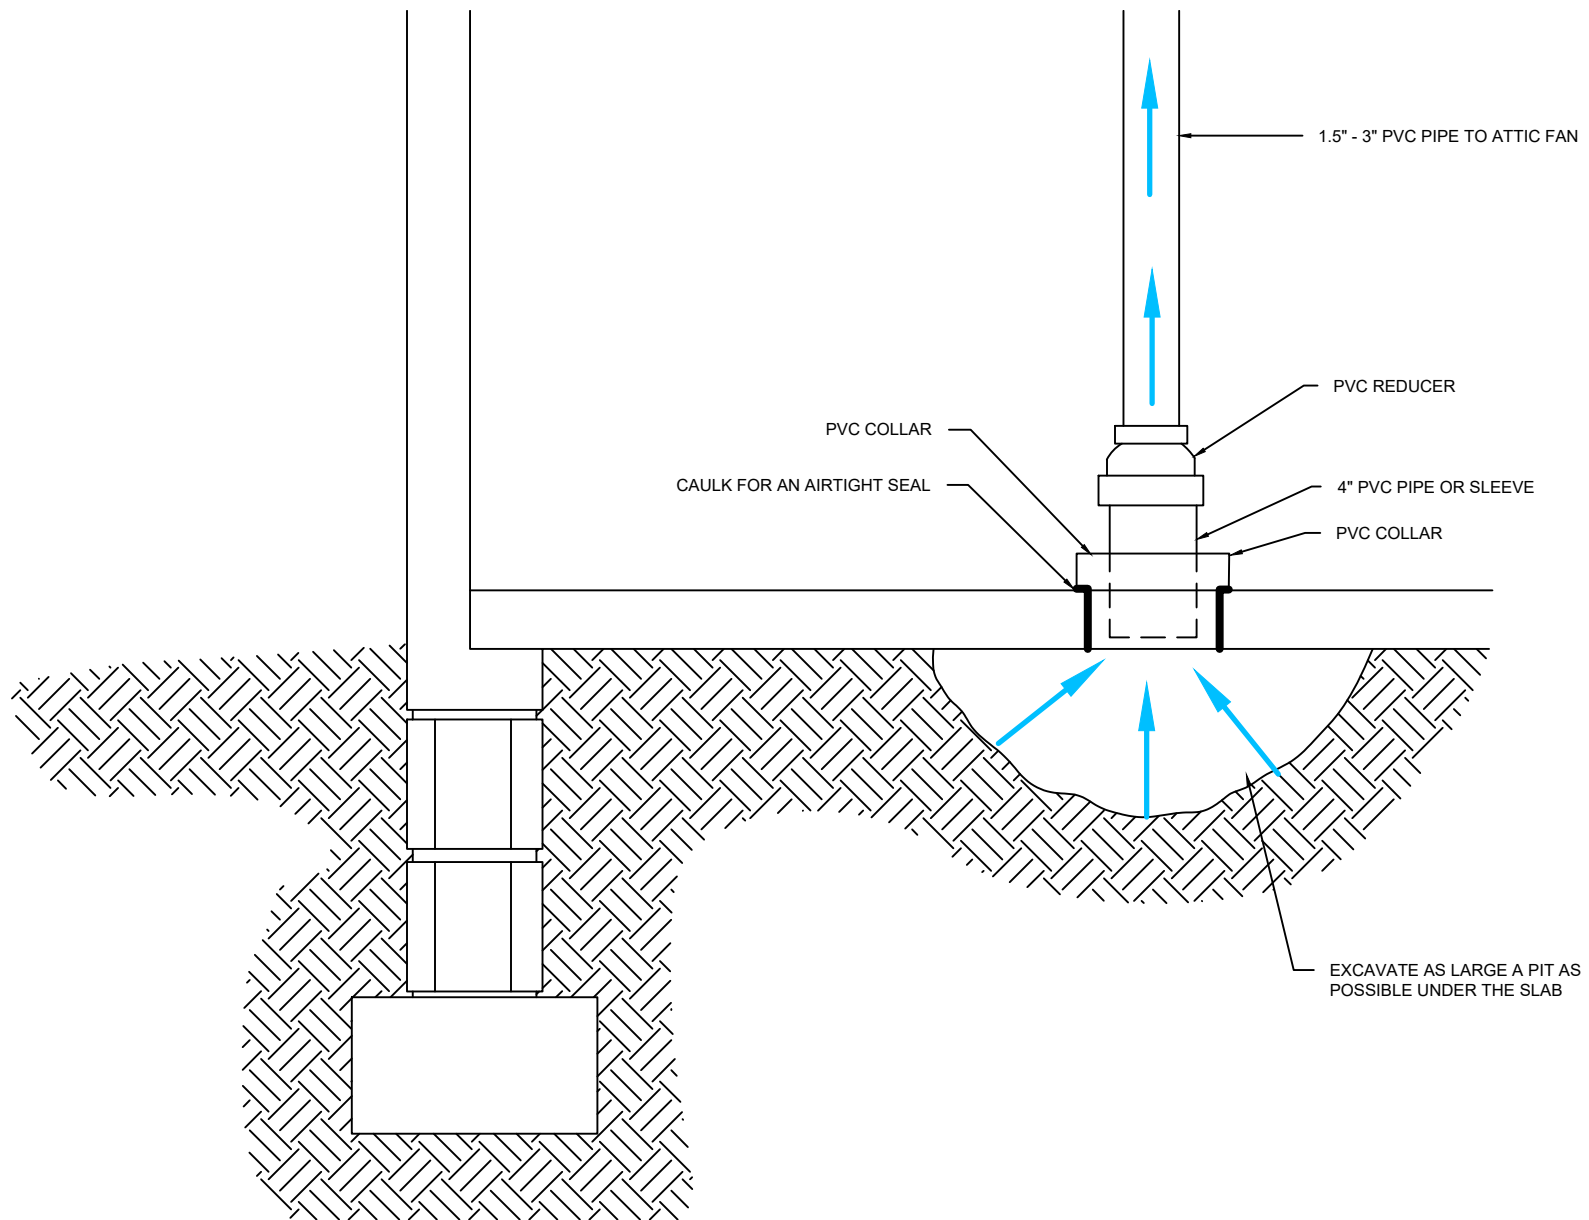
FIGURE  
 NUMBER  
**4**

**SUB-SLAB DEPRESSURIZATION**  
**POINT SCHEMATIC**

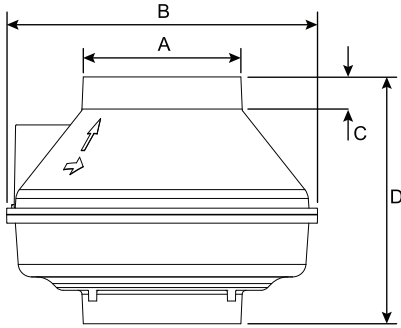
# DIMENSIONS

Model/Modèle	A	B	C	D
Rn1	4 15/32 (114)	10 (254)	1 1/4 (32)	9 1/4 (235)
Rn2	4 15/32 (114)	10 (254)	1 1/4 (32)	9 1/4 (235)
Rn2X	5 7/8 (149)	11 1/2 (292)	1 1/4 (32)	9 1/4 (235)
Rn3	5 7/8 (149)	11 1/2 (292)	1 1/4 (32)	9 1/4 (235)

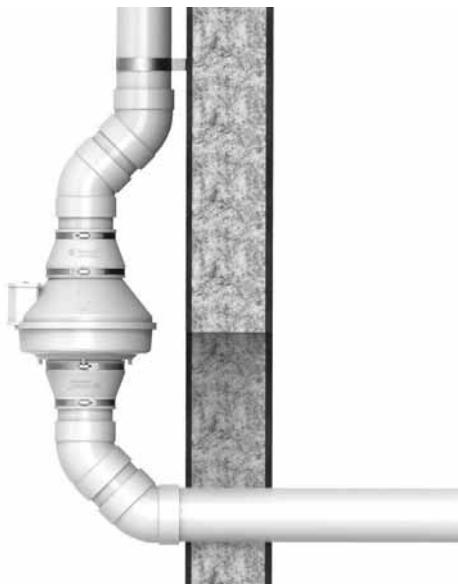
Radon fans are to be installed in the vertical orientation ONLY.

DO NOT connect fan directly to building structure

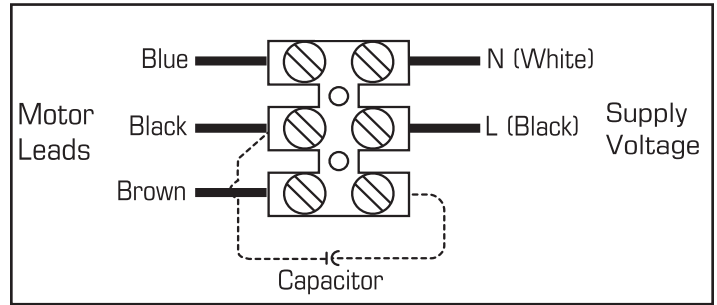
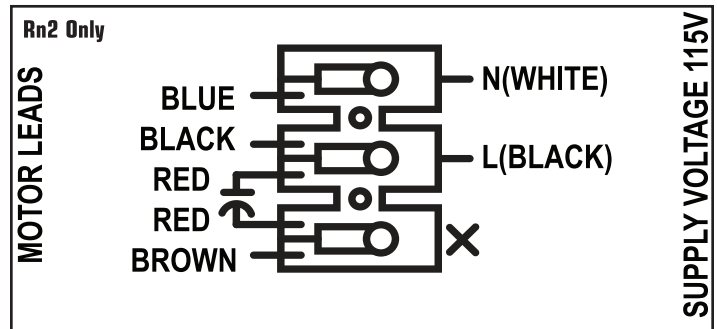
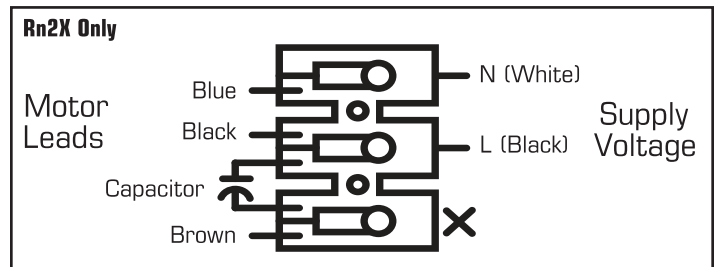
# WIRING DIAGRAM

There are typically three wires to be connected to an electrical fan; Load, Neutral and Ground. Load provides power to the fan, Neutral is for returning current and closing the electrical circuit, and Ground is for an additional path to safely return current to the ground, in case of an accidental electrical short in the fan and/or discharging of fan metal components.

Fantech radon fans are permanently connected appliances employing a reinforced polymeric construction. The non-conductive construction functions as a "Double Insulated" protective System (Complies with Standard for Double Insulation Systems for Use in Electrical Equipment, UL 1097), thus eliminating the need for a grounding conductor. All Fantech radon fans are tested and reviewed by Underwriter Laboratories, a 3rd party independent safety governing body, and deemed suitable for outdoor use (Standard for Safety-Electric Fans, UL 507).

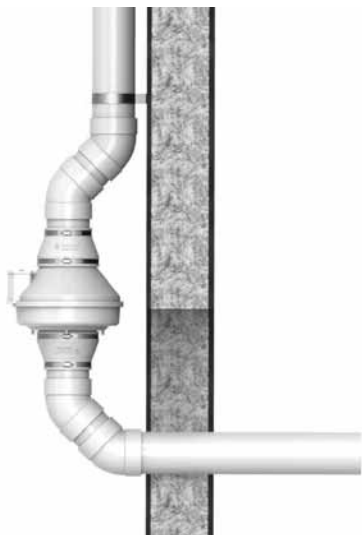
Les ventilateurs à radon doivent être installés dans le sens vertical SEULEMENT.

NE PAS brancher le ventilateur directement dans la structure du bâtiment.

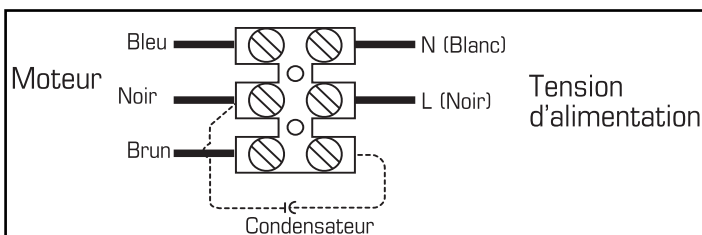
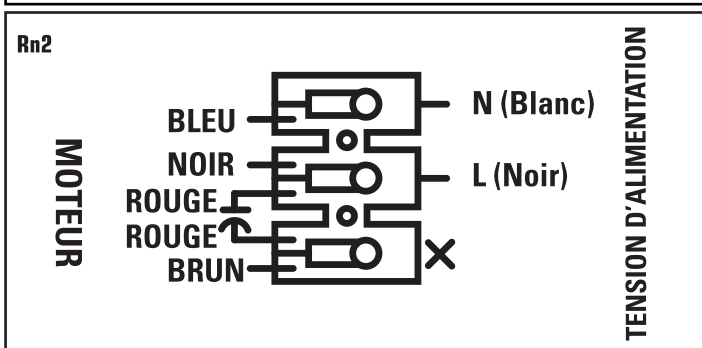
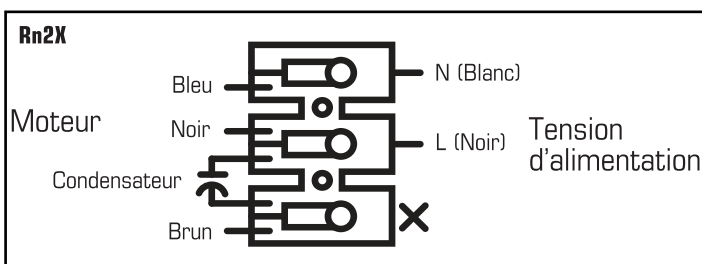
## SCHÉMA ÉLECTRIQUE

Il y a généralement trois fils à connecter à un ventilateur électrique, charge, neutre et mise à terre. La charge alimente le ventilateur, le neutre sert à rétablir le courant et à fermer le circuit électrique, et le fil de mise à terre à un chemin supplémentaire permettant de renvoyer le courant au sol en toute sécurité, en cas de court-circuit accidentel du ventilateur et / ou de décharge du ventilateur composants métalliques.

Les ventilateurs pour radon Fantech sont des appareils connectés en permanence utilisant une construction en polymère renforcé. La construction non conductrice fonctionne comme un système de protection «à double isolation» (conforme à la norme pour les systèmes à double isolation pour utilisation dans les équipements électriques, UL 1097), éliminant ainsi la nécessité d'un conducteur de mise à la terre. Tous les ventilateurs pour radon Fantech sont testés et examinés par Underwriter Laboratories, organisme de réglementation de la sécurité indépendant, et jugés utilisables à l'extérieur (norme relative aux ventilateurs électriques de sécurité, UL 507).
